HALLMARK BUILDING SUPPLIES, INC. WINDLOAD TEST REPORT

ASTM D5206 WINDLOAD TESTING ON LDC-619 INTERLOCKING PANELS, LEVANTE SIDING

J3219.04-109-40

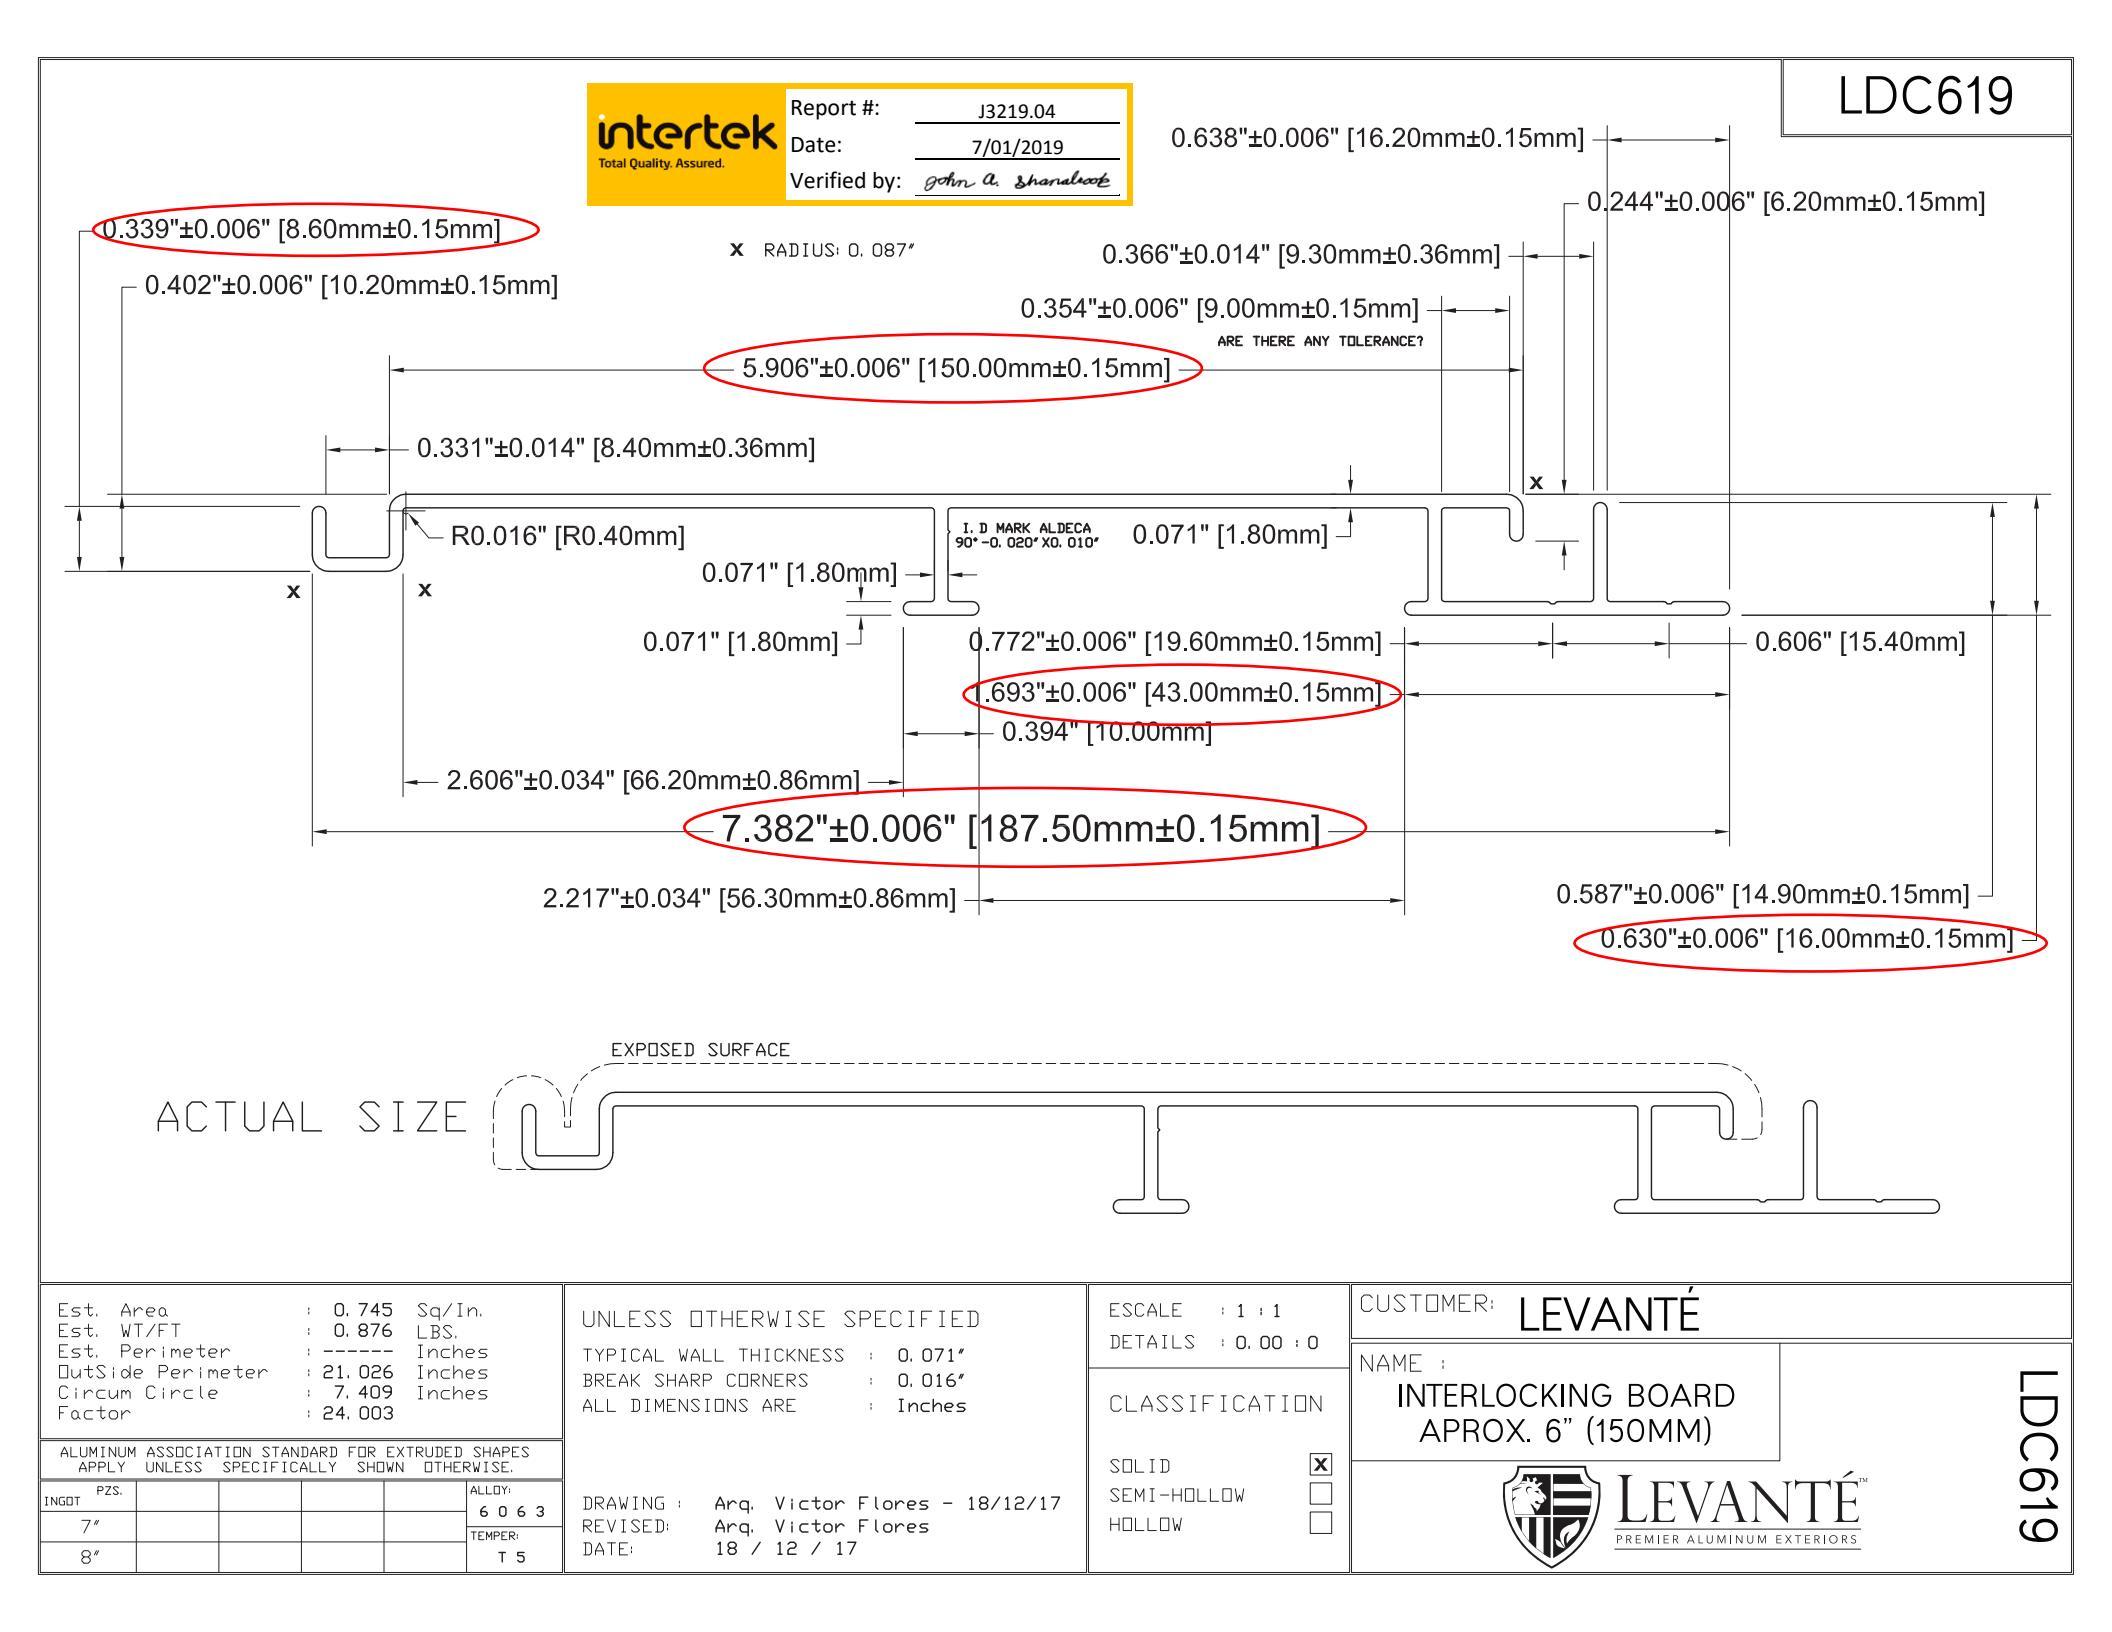
The test specimen drawings have been reviewed by Intertek B&C and are representative of the test specimens reported herein. Test specimen construction was verified by Intertek B&C per the drawings included in this report. Any deviations are documented herein or on the drawings.
