HALLMARK BUILDING SUPPLIES INC.

WINDLOAD TEST REPORT

ASTM D5206 WINDLOAD TESTING ON LSM-619 SELF-MATING PANELS LEVANTE SIDING

J3219.01-109-40

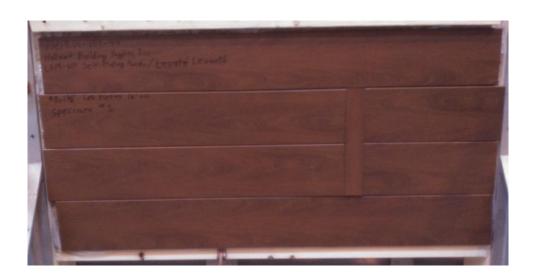
Photo No. 1 Specimen #1 Prior to Testing

Each specimen consisted of four horizontal courses of panels mounted independently of one another. A vertical transition strip was installed in the second and third courses over the sistered stud.

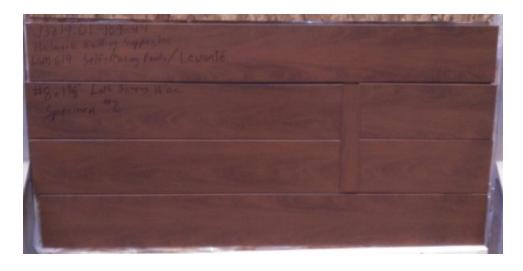
Photo No. 2 Specimen #2 Prior to Testing

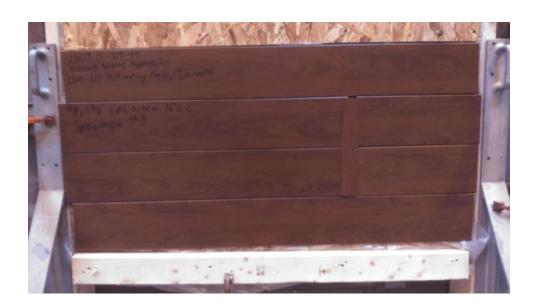
Photo No. 3 Specimen #3 Prior to Testing

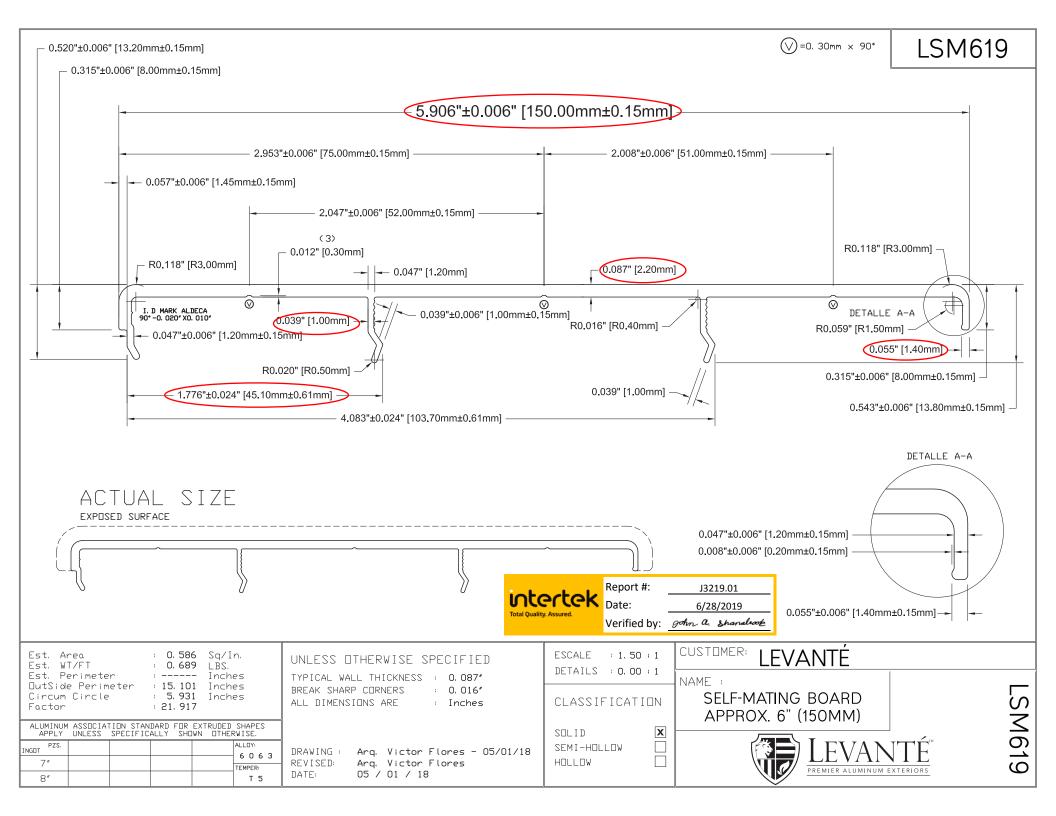
The test specimen drawings have been reviewed by Intertek B&C and are representative of the test specimens reported herein. Test specimen construction was verified by Intertek B&C per the drawings included in this report. Any deviations are documented herein or on the drawings.
