# Distinctive Aluminum Wood Grain Surface Designed for Commercial & Residential Use.

# LEVANTÉ® COMPONENT SYSTEM

# DECKING INSTALLATION GUIDELINES

**ASTM E84-19a**, Standard Test Method for Surface Burning Characteristics of Building Materials

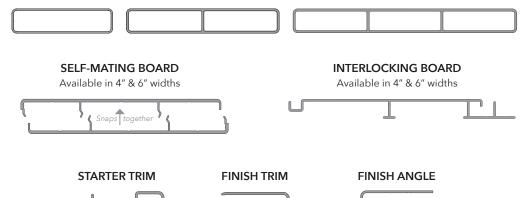
#### STANDARD BOARD

Available in 2", 4" & 6" widths

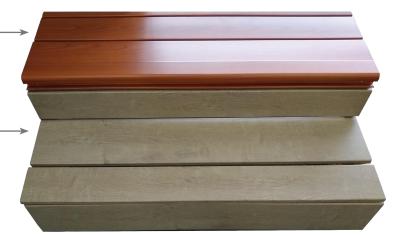
Riser: 6" Self-Mating Board and Tread:

- (1) 4" Self-Mating Board,
- (1) 6" Self-Mating Board (Nosing preferred install)
- (2) 6" Self-Mating Boards on Tread)

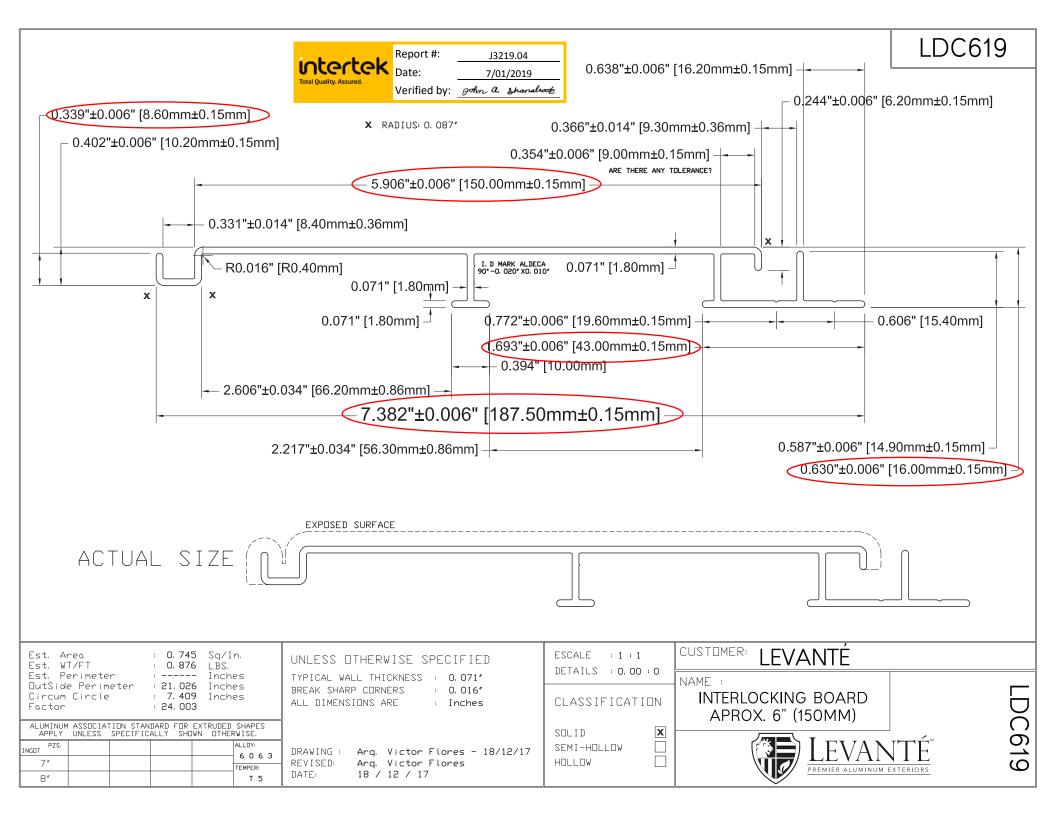
The test specimen drawings have been reviewed by Intertek B&C and are representative of the test specimens reported herein. Test specimen construction was verified by Intertek B&C per the drawings included in this report. Any deviations are documented herein or on the drawings.

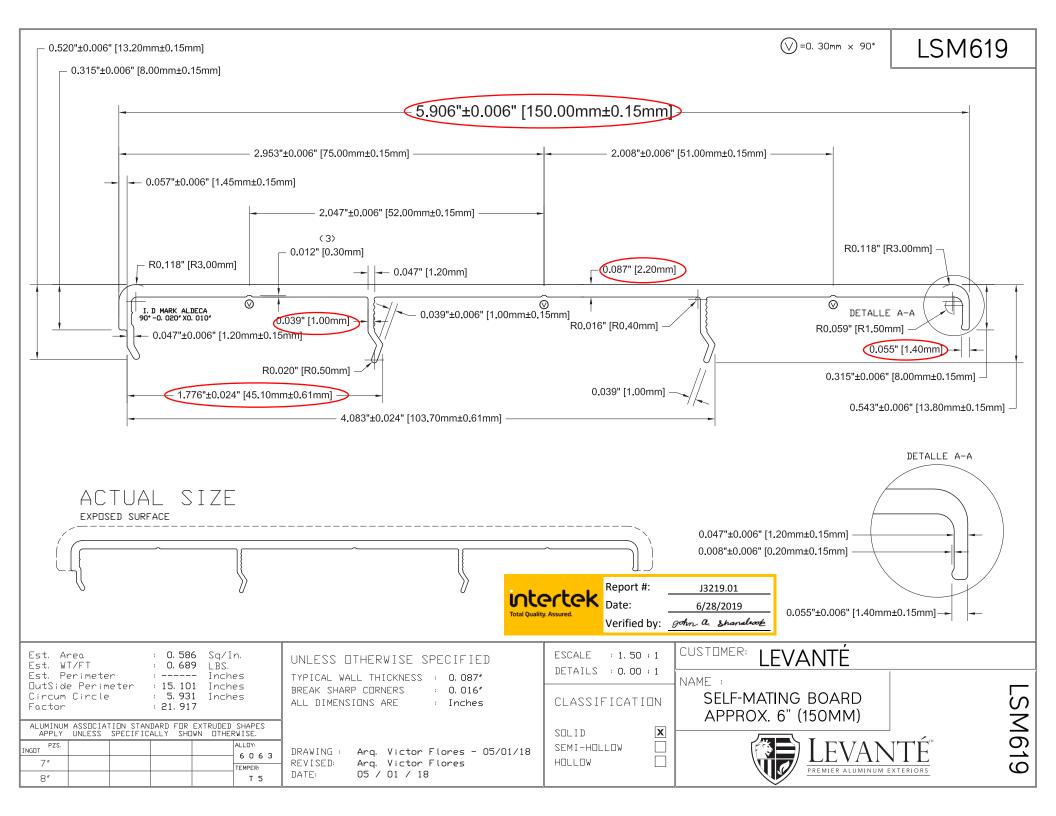
The test specimen drawings have been reviewed by Intertek B&C and are representative of the test specimens reported herein. Test specimen construction was verified by Intertek B&C per the drawings included in this report. Any deviations are documented herein or on the drawings.

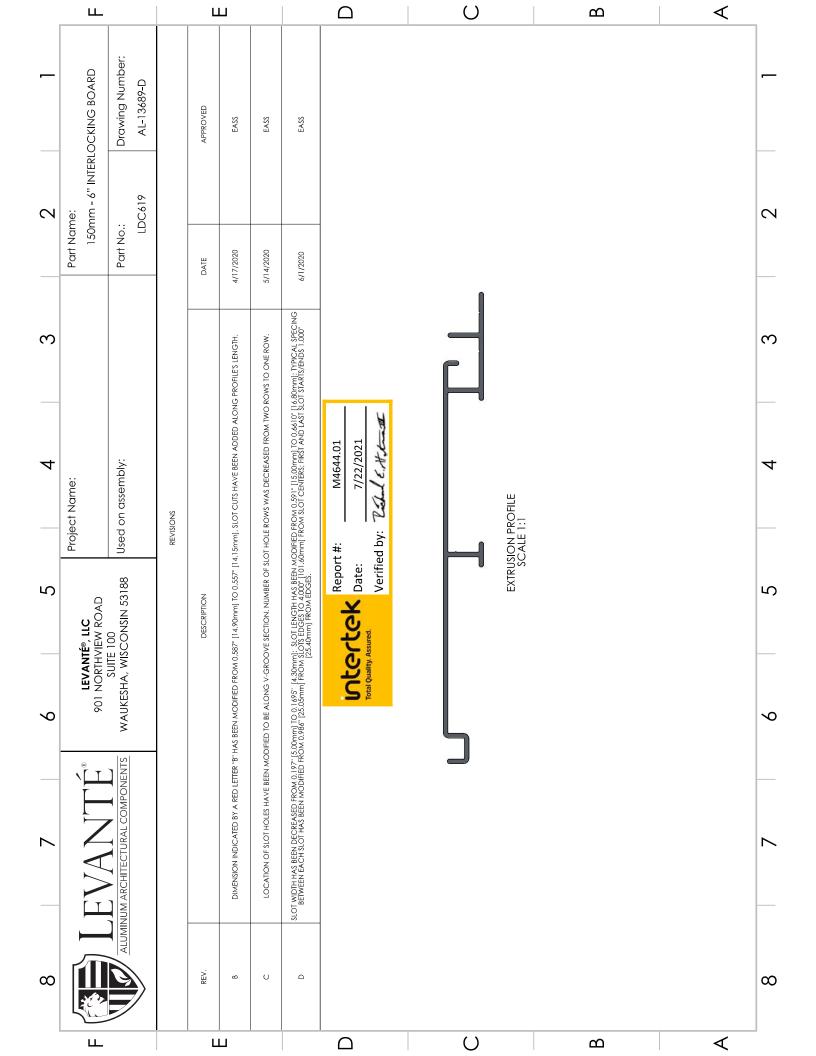
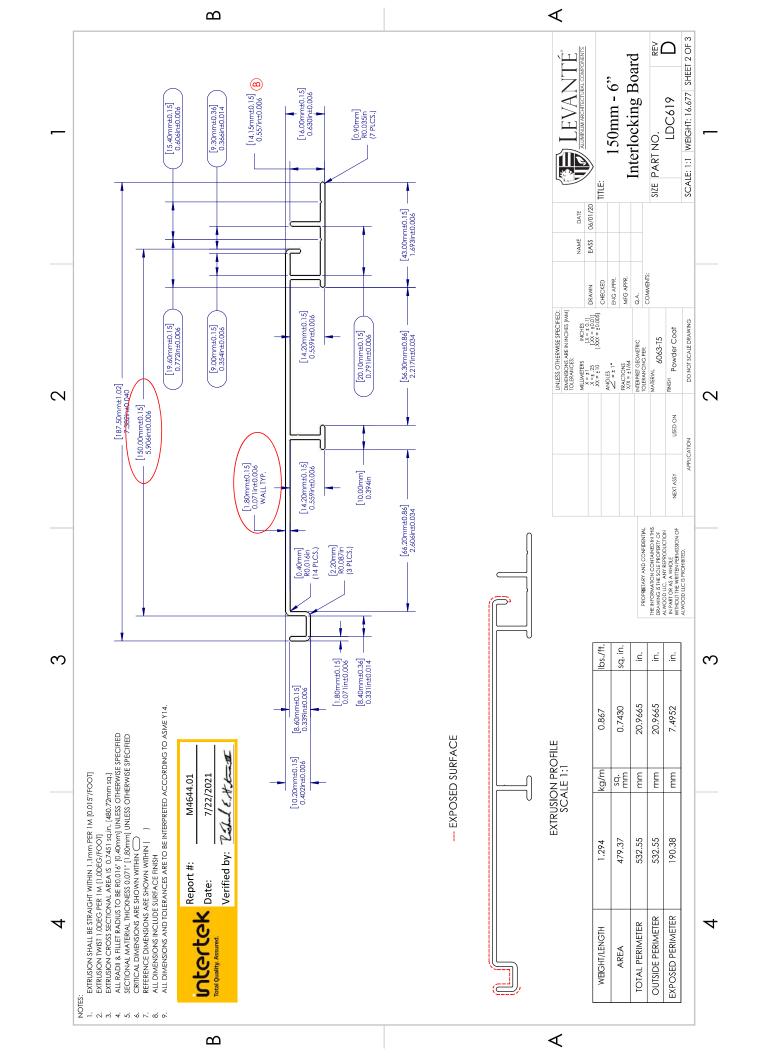
The test specimen drawings have been reviewed by Intertek B&C and are representative of the test specimen(s) reported herein. Test specimen construction was verified by Intertek B&C per the drawings included in this report. Any deviations are documented herein or on the drawings.
